SCHOOL DISTRICT OF CLAYTON

LONG-RANGE FACILITIES

MASTER PLAN

2024-2025

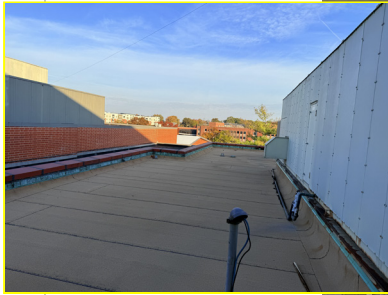
North Side

COVERING CAST STONE CAPS
WITH METAL COPINGS
RECOMMENDED

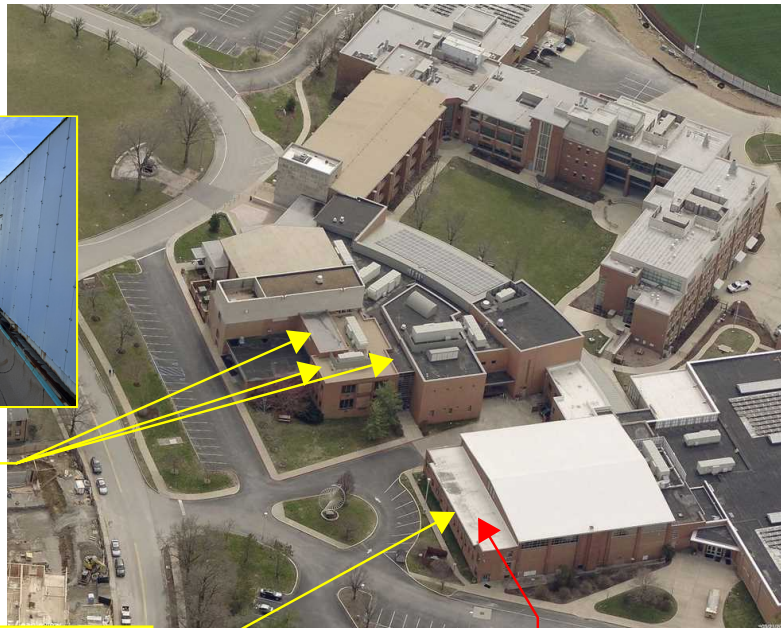
COVERING CAST STONE CAPS
WITH METAL COPINGS
RECOMMENDED

THIS AREA OF TPO HAS BUBBLED AND WARPED, HAS SEDIMENT BUILDUP, AND WATER MARKS. IN COMPARISON TO OTHER TPO INSTALLED AT THE SAME TIME, THIS SEEMS TO EXHIBIT WATER AND DRAINAGE ISSUES.

REPLACEMENT OF COPPER
FLASHINGS NEEDED

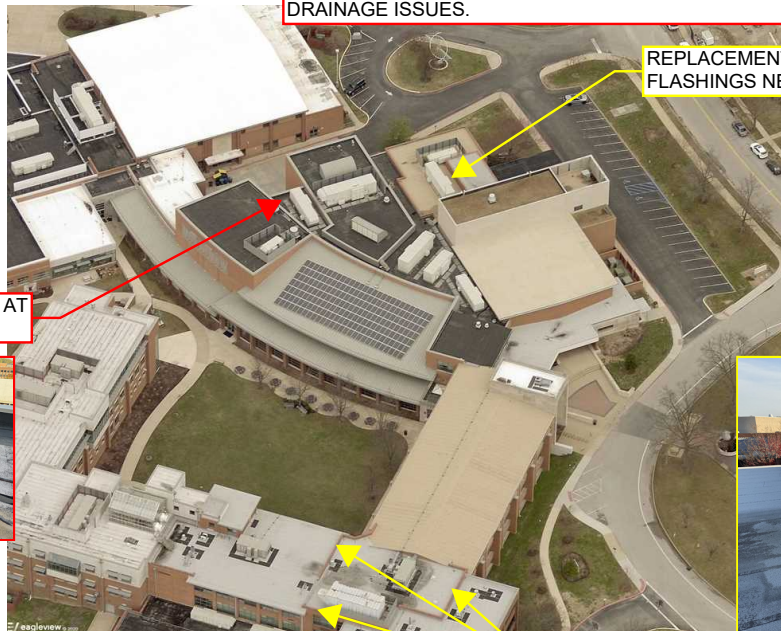
WATER PONDING HERE AT
ROOF DRAIN

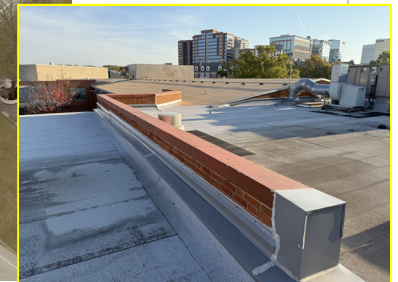
COVERING CAST STONE CAPS
WITH METAL COPINGS
RECOMMENDED

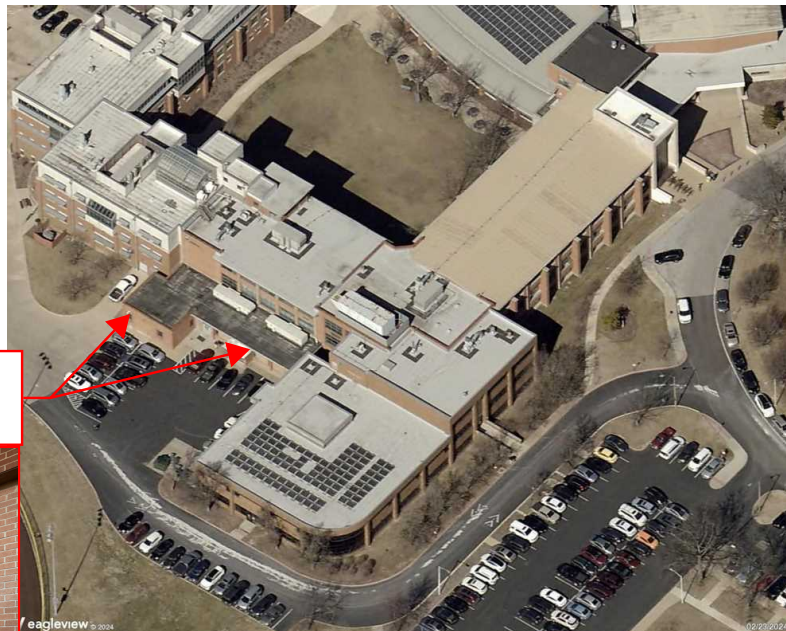
South Side

REPLACEMENT OF ALL
HOLLOW METAL DOORS AND
WINDOWS IN THIS AREA
NECESSARY

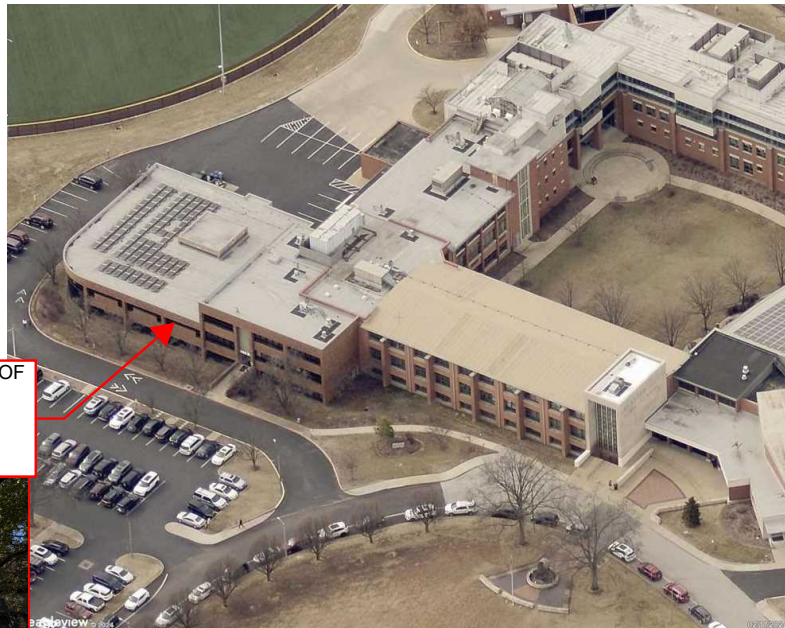
East Side

ALL SOFFITS ON THIS SIDE OF BUILDING SHOW WATER DAMAGE AND NEED INVESTIGATION AND REPLACEMENT

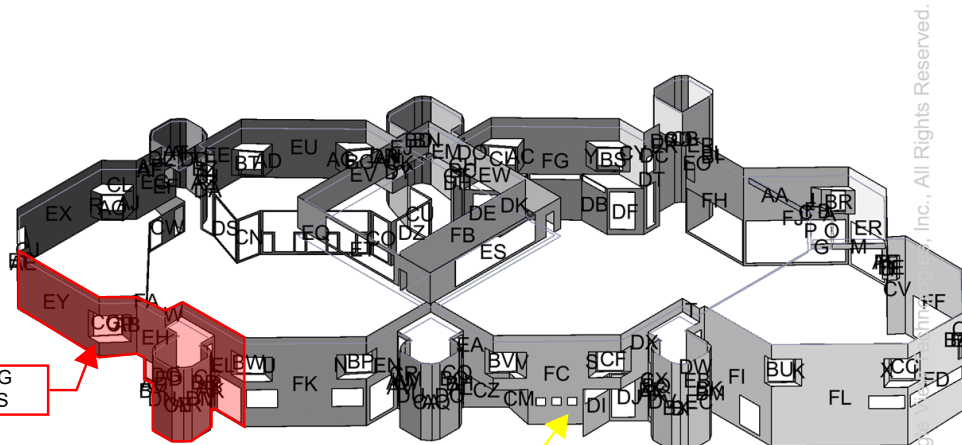
HVAC CONDENSATE LINE
WATER HAS CREATED WATER
DAMAGE ON BUILDING FACE
AND ON PAVEMENT

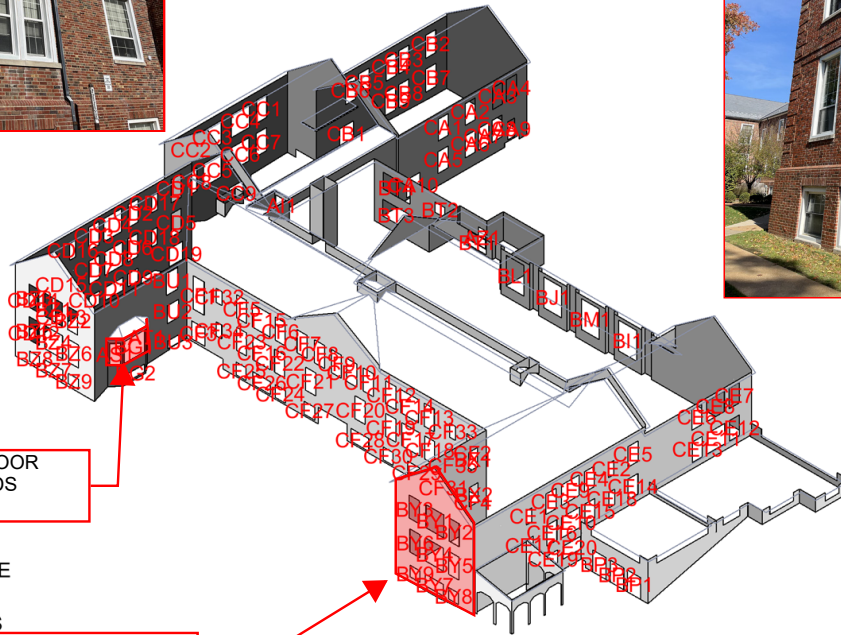
WINDOW TRIM IS IN POOR
CONDITION AND NEEDS
REPLACING

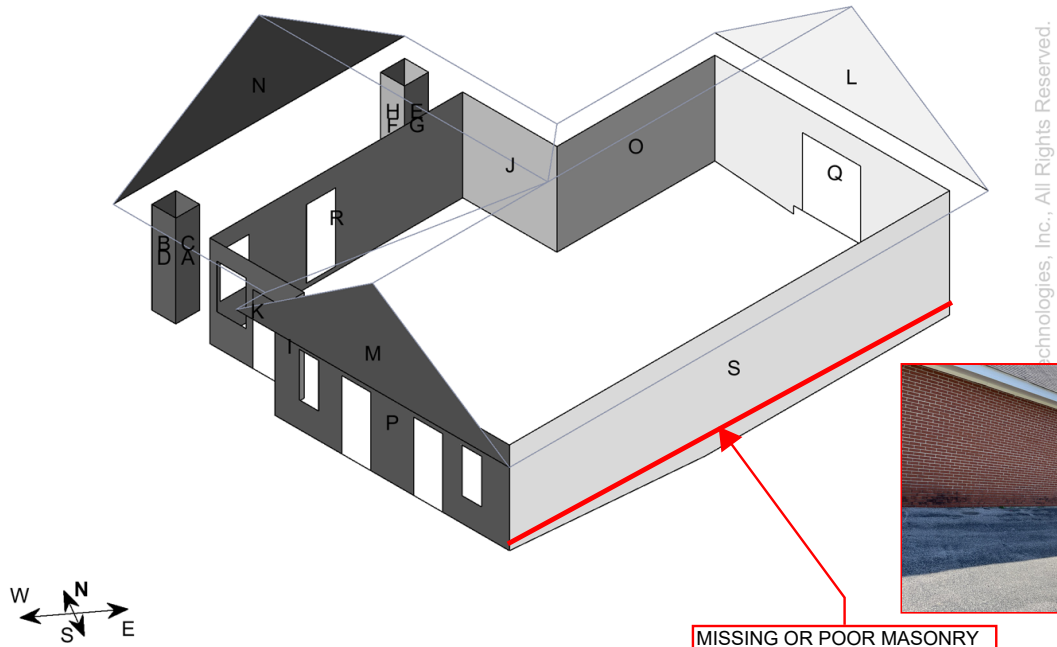
MISSING OR POOR MASONRY
WEEPS HAVE LEAD TO WATER
DAMAGE ON FACE OF WALL
BELOW WEEPS
