SCHOOL DISTRICT OF CLAYTON

LONG-RANGE FACILITIES

MASTER PLAN

2024-2025

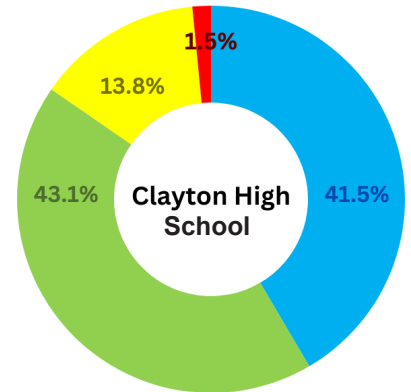
Section	Points Possible	Total Earned	Percent
1.0 Educational Adequacy	200	148	74%
2.0 Environment for Education	200	148	74%
3.0 The School Site	100	90	89%
4.0 Building Safety and Security	200	170	85%
5.0 Structural condition and Electrical/Mechanical Systems	200	166	83%
6.0 Plant Maintainability	100	87	87%
Total	1000	808	81%

Overall, scores for Clayton High School are satisfactory, but several areas could benefit from improvement. Many classrooms, particularly math, are slightly undersized and there is a need for additional SSD/English classrooms. On the contrary, the science rooms are appropriately sized. This begins to highlight how the newer sections of the building feature larger, flexible layouts and ample natural light, but the older areas, particularly the lower level, lack both flexibility and sufficient lighting. The library, however, is well-sized, recently renovated, and offers adaptable spaces for both students and teachers.

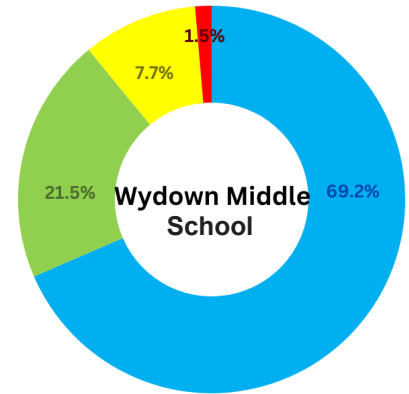
Section	Points Possible	Total Earned	Percent
1.0 Educational Adequacy	200	166	83%
2.0 Environment for Education	200	180	90%
3.0 The School Site	100	80	80%
4.0 Building Safety and Security	200	183	91%
5.0 Structural condition and Electrical/Mechanical Systems	200	186	93%
6.0 Plant Maintainability	100	95	95%
Total	1000	890	89%

Overall, Wydown Middle School is well-maintained, built with durable materials, and functions effectively, though most classrooms are slightly undersized. The multipurpose communal areas aid in making classroom spaces feel larger, but the gym is too small to meet school needs. Bleacher functionality is limited due to these space constraints, making it difficult to fully utilize the gym for both internal and external events. Parking is also inadequate for school events, and access is challenging due to the lack of a bus service combined with the school's location within the district. There is a need for dedicated teacher and admin spaces, as some have converted former storage closets into offices. The physical education of students and school-wide usage of the grass field would benefit from converting the grass field into turf. Lastly, some exterior doors sometimes malfunction due to pressure issues, and motorized shades are nonfunctional, resulting in inconsistent lighting in spaces.

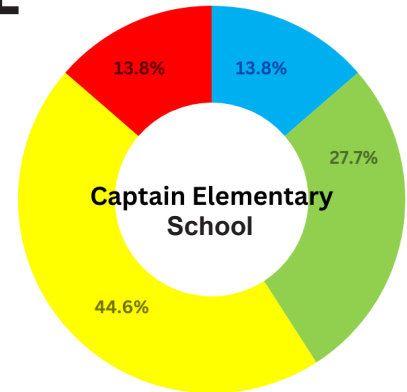
Section	Points Possible	Total Earned	Percent
1.0 Educational Adequacy	200	119	59%
2.0 Environment for Education	200	121	61%
3.0 The School Site	100	66	66%
4.0 Building Safety and Security	200	144	72%
5.0 Structural condition and Electrical/Mechanical Systems	200	148	74%
6.0 Plant Maintainability	100	67	67%
Total	1000	665	66%

In summary, Captain Elementary's open floor plan, while collaborative in concept, is not conducive for all educational activities or learning for all students. The absence of full height dividing walls on the upper level creates sound transmittance from classroom to classroom. In addition, the lockers and open shelves that divide the space create inconsistent classroom configurations while inadequate teacher storage creates clutter and disrupts the learning environment. Security concerns arise from the open design with it being difficult to secure the building in addition to egress paths to stairwells cutting directly through classroom spaces.

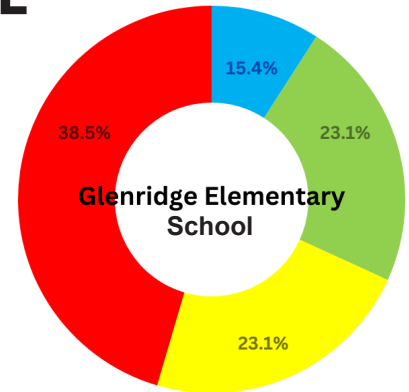
Section	Points Possible	Total Earned	Percent
1.0 Educational Adequacy	200	110	55%
2.0 Environment for Education	200	100	50%
3.0 The School Site	100	67	67%
4.0 Building Safety and Security	200	141	70%
5.0 Structural condition and Electrical/Mechanical Systems	200	123	61%
6.0 Plant Maintainability	100	60	60%
Total	1000	600	60%

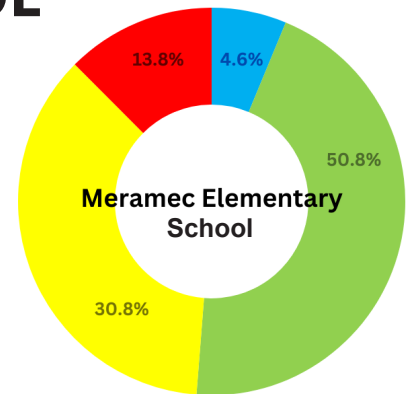
Section	Points Possible	Total Earned	Percent
1.0 Educational Adequacy	200	125	63%
2.0 Environment for Education	200	129	64%
3.0 The School Site	100	73	73%
4.0 Building Safety and Security	200	150	75%
5.0 Structural condition and Electrical/Mechanical Systems	200	142	71%
6.0 Plant Maintainability	100	72	72%
Total	1000	691	69%

In summary, Meramec Elementary school's dated design has led to hindered functionality and safety in comparison to current standards. The entry sequence is unclear, causing confusion and leading visitors to inappropriate doors, which disrupts student learning and raises safety concerns. There are insufficient accessible entrances, exits, and circulation routes throughout the building while around the exterior, foot and vehicular traffic often overlap at busy times, creating safety risks.

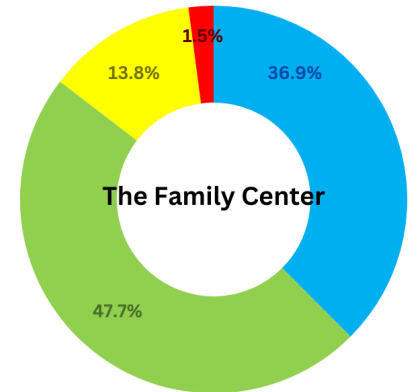
Section	Points Possible	Total Earned	Percent
1.0 Educational Adequacy	200	156	78%
2.0 Environment for Education	200	163	81%
3.0 The School Site	100	78	78%
4.0 Building Safety and Security	200	180	90%
5.0 Structural condition and Electrical/Mechanical Systems	200	162	81%
6.0 Plant Maintainability	100	83	83%
Total	1000	822	82%

In summary, The Family Center is satisfactory but has some areas it could improve. The building materials are generally in good condition, and classrooms are mostly adequate to spacious, but there is no suitable space for the Stay, Play, and Learn program, which is in the high school. The school could benefit from more indoor space for gross motor activities, and while all student-occupied spaces have access to natural light, the amount varies by classroom. Gay Field traffic is a safety concern due to speeding vehicles, and the single entrance/exit to the main parking area can cause traffic backups. While additional parking is not urgently needed, it could benefit circulation during pick up and drop off or for community events.

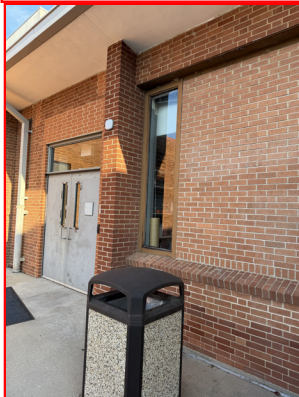
South Side

4. DOORS AND WINDOWS HAVE A YELLOW RATING.
5. REPLACEMENT OF ALL HOLLOW METAL DOORS AND WINDOWS IN THE AREA UNDER 1996 MOD BIT ROOF IS NECESSARY AS FRAMES ARE SEVERELY DAMAGED.

REPLACEMENT OF ALL
HOLLOW METAL DOORS AND
WINDOWS IN THIS AREA
NECESSARY

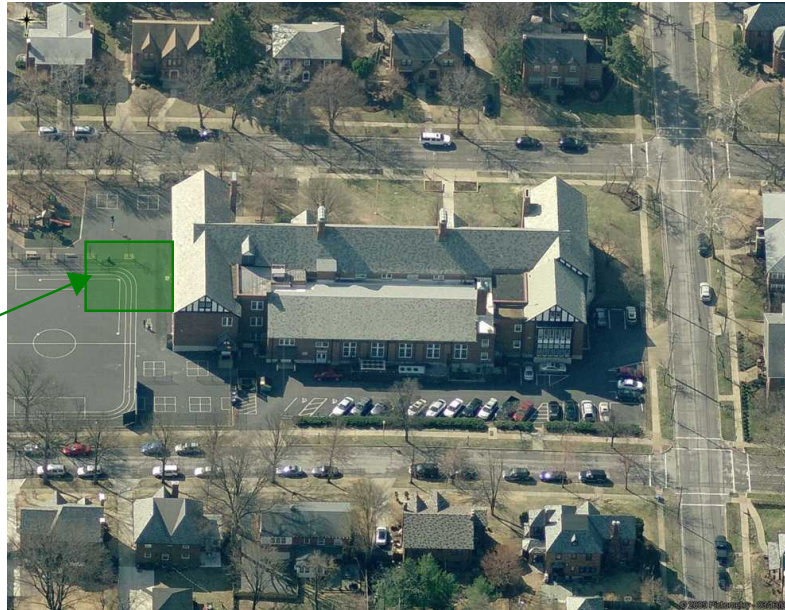
North Side

APPROXIMATE AREA
OF ADDITION MISSING
FROM PHOTOGRAPH

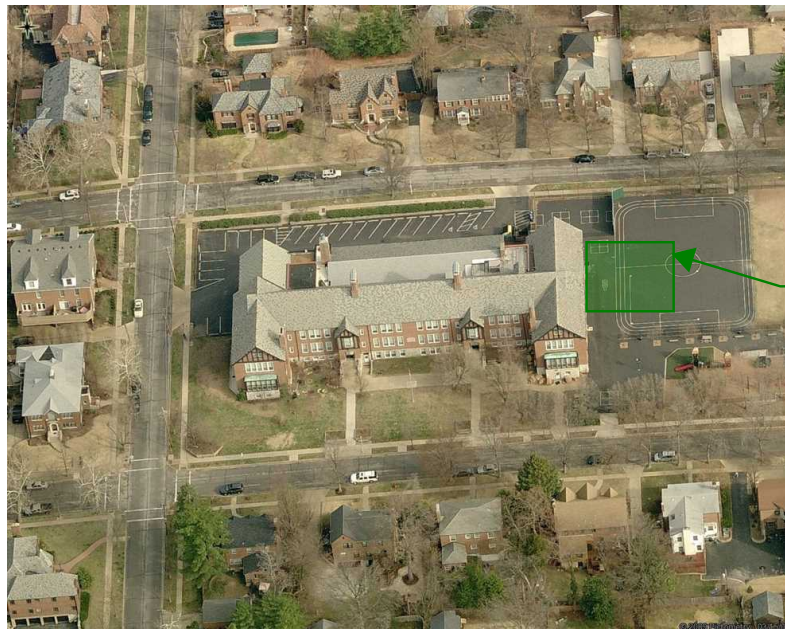
South Side

APPROXIMATE AREA
OF ADDITION MISSING
FROM PHOTOGRAPH

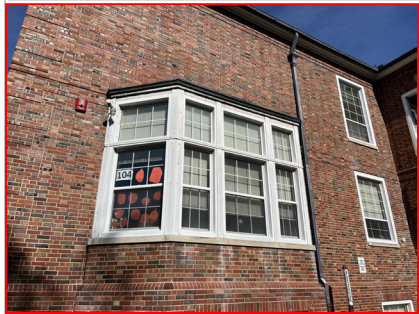
WINDOW TRIM IS IN POOR
CONDITION AND NEEDS
REPLACING

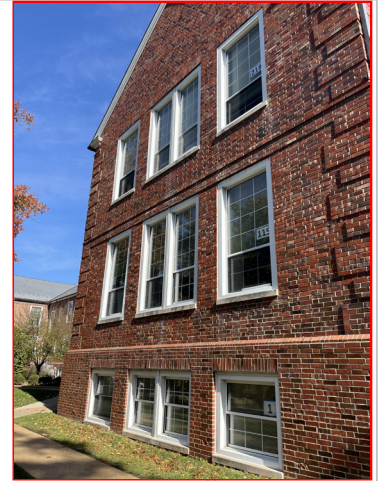
ALL STEEL LINTELS ON THIS
FACADE ARE RUSTING AND IN
NEED OF REPAIR AND/OR
REPLACEMENT (SEVERE)

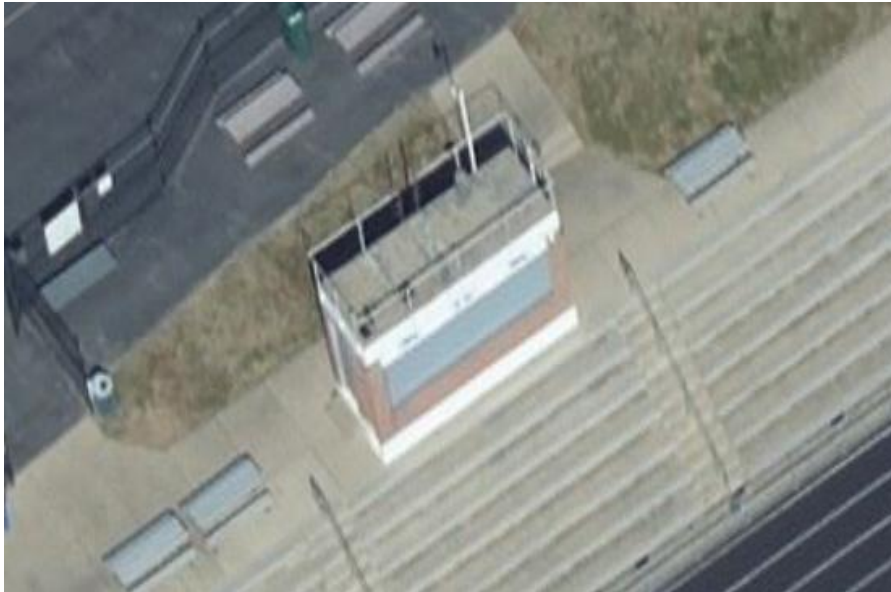
PRESS BOX

1. ROOF IS IN POOR CONDITION AND HAS A RED RATING.
2. SEALANT CURRENTLY HAS A RED RATING.
3. MASONRY CLADDING IS IN POOR CONDITION AND HAS A RED RATING. MASONRY CLEANING NEEDED ON ALL SIDES OF BUILDING. SPOT TUCKPOINTING NEEDED ON ALL SIDES OF BUILDING.
4. WINDOWS AND DOORS HAVE A RED RATING.
5. COMPLETE ENVELOPE RENOVATION IS NEEDED. DEMOLITION AND REPLACEMENT OF FACILITY IS WARRANTED.

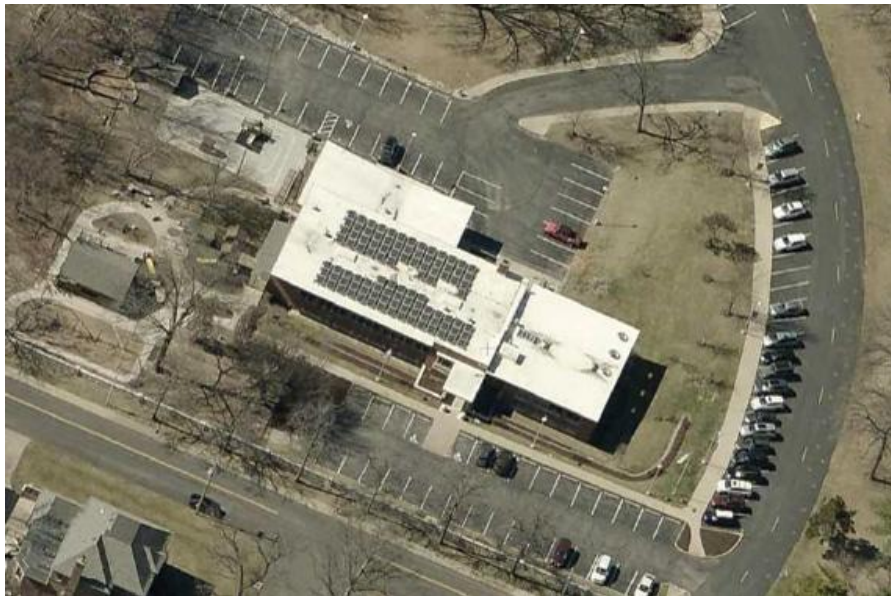
THE FAMILY CENTER

1. ROOFS ARE IN GOOD CONDITION AND HAVE A GREEN RATING.
2. SEALANT CURRENTLY HAS A YELLOW RATING.
3. MASONRY IS IN GOOD CONDITION AND HAS A GREEN RATING.
4. WINDOWS AND DOORS HAVE A YELLOW RATING.
